6803 S. 27th Street Wetland Delineation JSD Professional Services, Inc. Page 4 / October 26th, 2015

Approx. 10-Acre Study Area Located at 6803 S. 27th Street City of Franklin Milwaukee County, WI

WETLAND BOUNDARY MAP

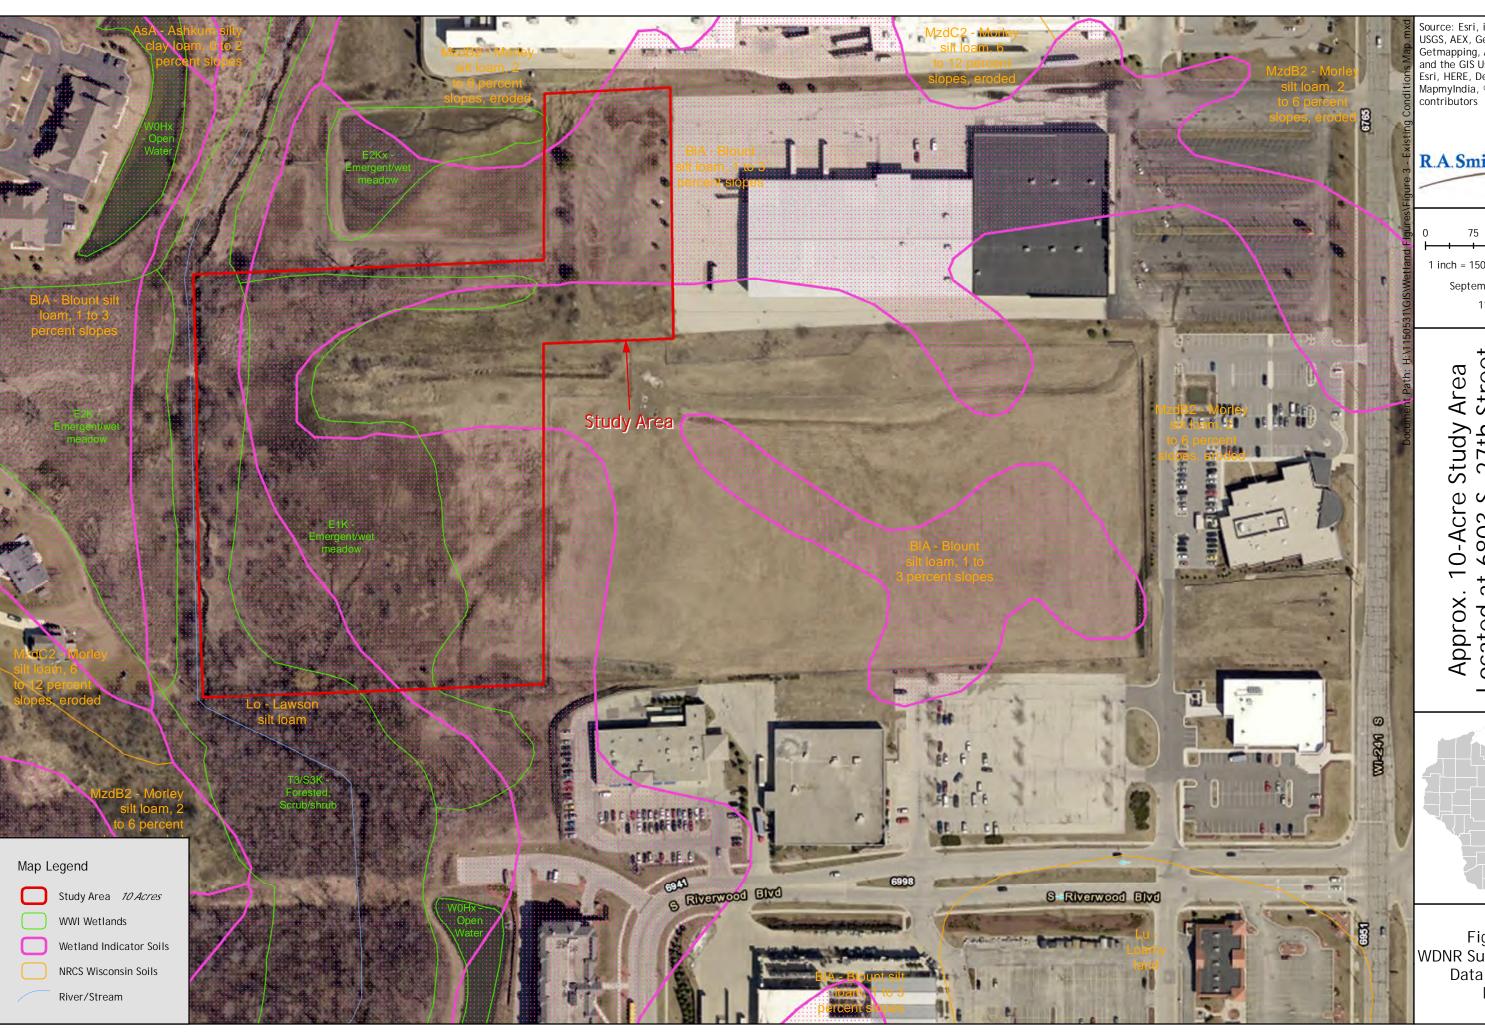
FIGURE NO. 2

As shown on Figure 2 in Appendix 1, W-1 is 0.26 acre within the Study Area. This wetland is dominated by reed canary grass (*Phalaris arundinacea*), giant reed grass (*Phragmites australis*), narrow leaved cattail (*Typha angustifolia*), grass-leaved goldenrod (*Euthamia graminifolia*), and lesser poverty rush (*Juncus tenuis*). The adjacent upland meadow contained many weed species, especially Kentucky blue grass (*Poa pratensis*), Queen Anne's lace (*Daucus carota*), Canada goldenrod (*Solidago canadensis*), bird's foot trefoil (*Lotus conrniculatus*) and gray dogwood (*Cornus racemosa*). Please refer to the site photos in Appendix 3 for various depictions of W-1 and the adjacent uplands.

As shown on Figure 2 in Appendix 1, W-2 is the largest of the three wetlands and is 4.75-acres within the Study Area. It is shown as being an Emergent wet meadow (E1K) on Figure 5 which is consistent with the shallow marsh and fresh (wet) meadow plant communities observed by RASN. The mapped WWI wetland is fairly consistent with the size and location of W-2, except that it does not include one of the two ditches as observed and delineated by RASN. This wetland is directly connected with a ditched waterway about 8 to 10 feet wide that flows south along the far western end of the Study Area. This waterway originates from Mud Lake to the northwest of the site and ultimately connects with the Root River. The wetland is dominated by primarily by giant reed grass and narrow-leaved cattail and is bordered by the same low quality upland meadow that surrounds W-1. Please refer to the site photos in Appendix 3 for various depictions of W-2 and the adjacent uplands.

As shown on Figure 2 in Appendix 1, W-3 is a small, depressional wetland 0.06 acres in size. It is not shown as being a WWI mapped wetland on Figure 5. This wetland is low in quality, and dominated by primarily by giant reed grass. The immediate adjacent is an upland meadow with primarily scattered black locust (*Robimia pseduoacacia*) trees and weedy species especially Kentucky blue grass, Queen Anne's lace, Canada goldenrod, and English plantain (*Planatgo lanceolata*). In addition, there were large patches of giant reed grass growing upslope in many of the uplands which may be attributed to stormwater runoff from the adjacent parking lot. Please refer to the site photos in Appendix 3 for various depictions of W-3 and the adjacent uplands.

Based on the wetland assessment completed by RASN, three (3) wetlands were identified within the Study Area (Figure 2). The total acreage of wetland within the Study Area is 5.07 acres. One waterway was flows southerly along the far western property boundary. The waterway is fed by Mud Lake to the north and ultimately connects to the Root River which is roughly 2.5 miles southeast of the site. Based on aerial photographs, W-2 is connected to the waterway and thus the wetland is expected to fall under both US Army Corps of Engineers (Corps) and Wisconsin Department of Natural Resources (WDNR) jurisdictions. There was no direct connection of W-1 and W-3 to a waterway as observed by RASN. The final jurisdictional determinations of all of the wetlands rests with the Corps and WDNR.
