Approx. 10-Acre Study Area  
Located at 6803 S. 27th Street  
City of Franklin  
Milwaukee County, WI

### **Site Photographs**

Project/Site: Approx.10-Acre Site at 6803 S. 27th Street City/County: Milwaukee City of Franklin /  
 Applicant/Owner: JSD Professional Services, Inc. State: WI Sampling Date: September 28, 2015  
 Investigator(s): Heather D. Patti Section, Township, Range: SE 1/4 Sec 1, T5N, R21E  
 Landform (hillslope, terrace, etc.): terrace Local relief (concave, convex, none): none- flat  
 Slope (%): 0% Lat: \_\_\_\_\_ Long: \_\_\_\_\_ Datum: \_\_\_\_\_  
 Soil Map Unit Name: Blount silt loam, 1-3% slopes (BIA) WWI Classification: E1K  
 Are climatic / hydrologic conditions on the site typical for this time of year? Yes X No \_\_\_\_\_ (if no, explain in Remarks)  
 Are Vegetation N Soil N or Hydrology N significantly disturbed? Are "Normal Circumstances" present? Yes X No \_\_\_\_\_  
 Are Vegetation N Soil N or Hydrology N naturally problematic? (if needed, explain any answers in Remarks)

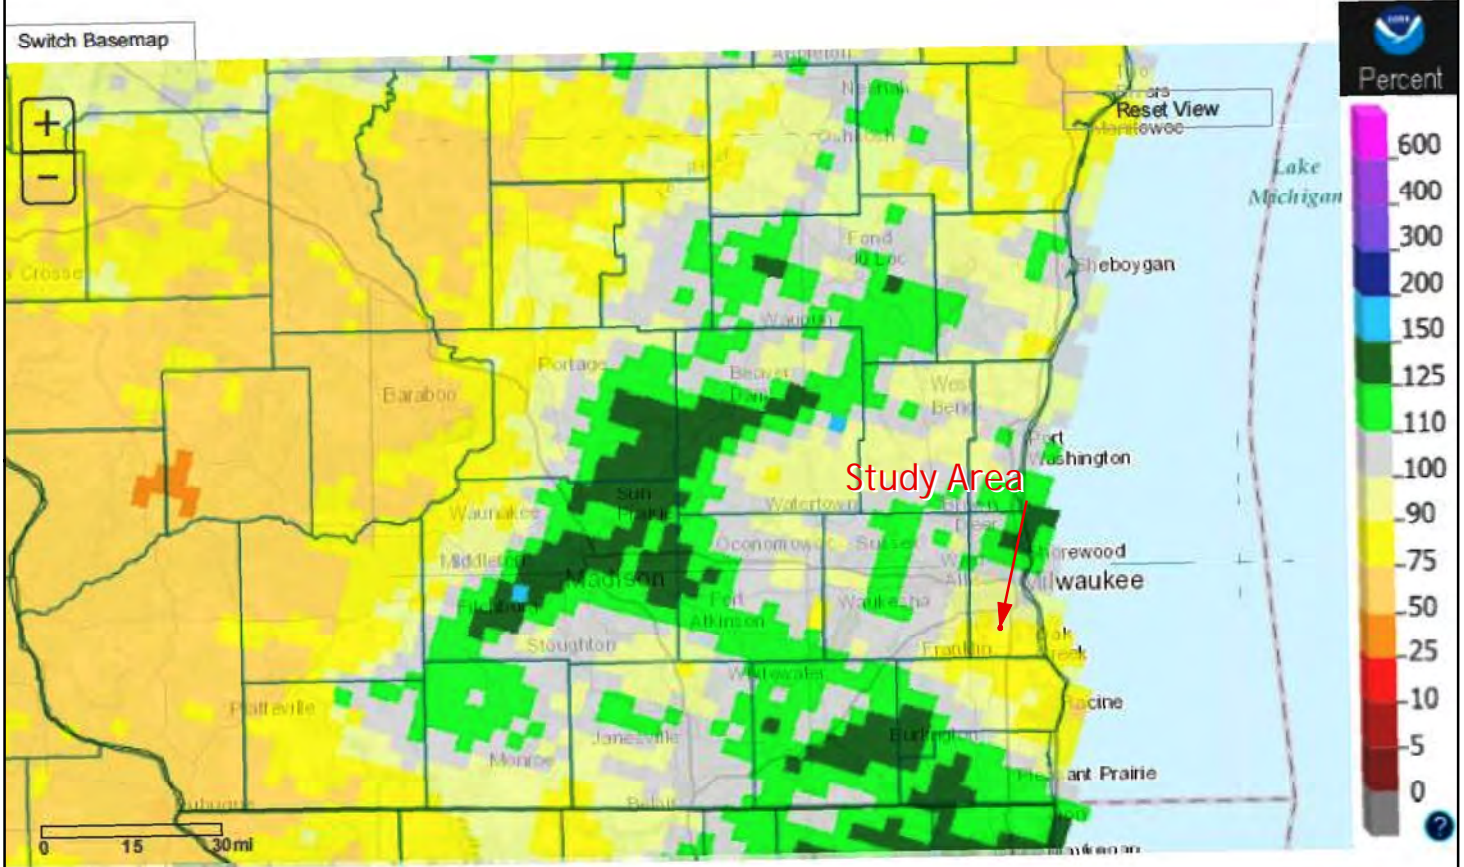
Figure 5  
90-Day Percent of  
Normal Precipitation Map  
Approx. 10-Acre Study Area  
Located at 6803 S. 27th Street  
City of Franklin  
Milwaukee County, WI

Milwaukee/Sullivan, WI: 90-Day Percent of Normal Precipitation  
Valid on: September 28, 2015 12:00 UTC

The project area falls within -90% to -75% of the normal precipitation range

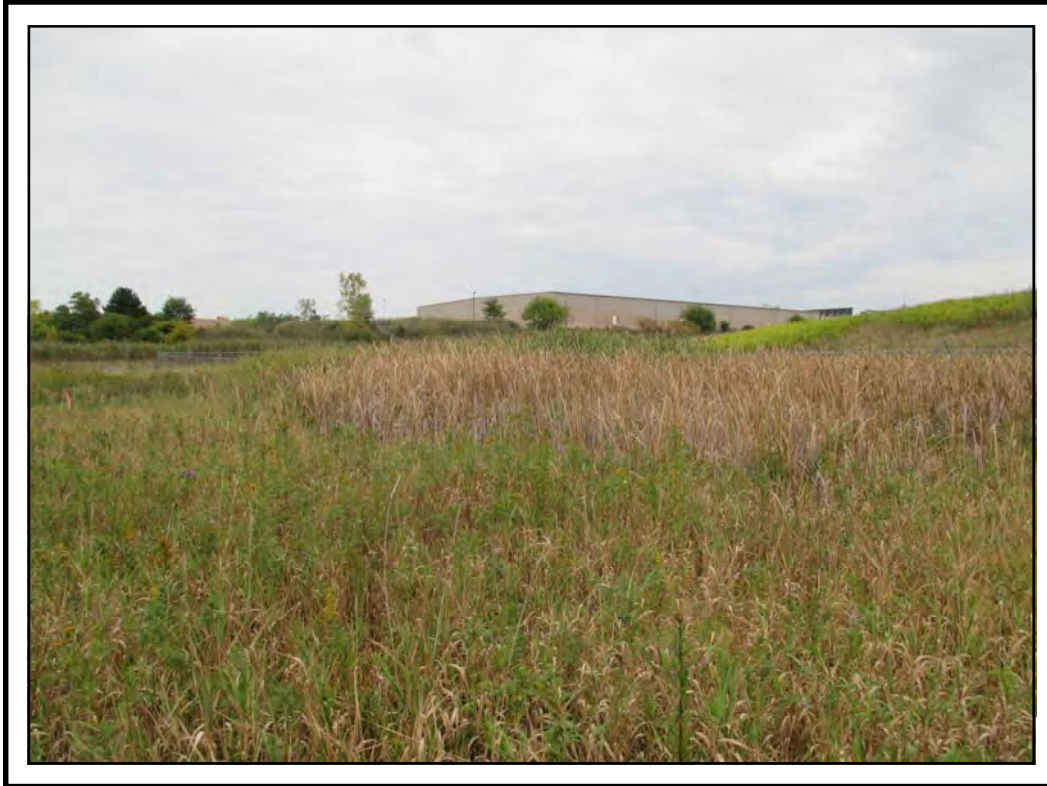
**Photograph 1 (9/28/15):** Northfacing view of W-1 which contains fresh (wet) meadow and shallow marsh plant communities.

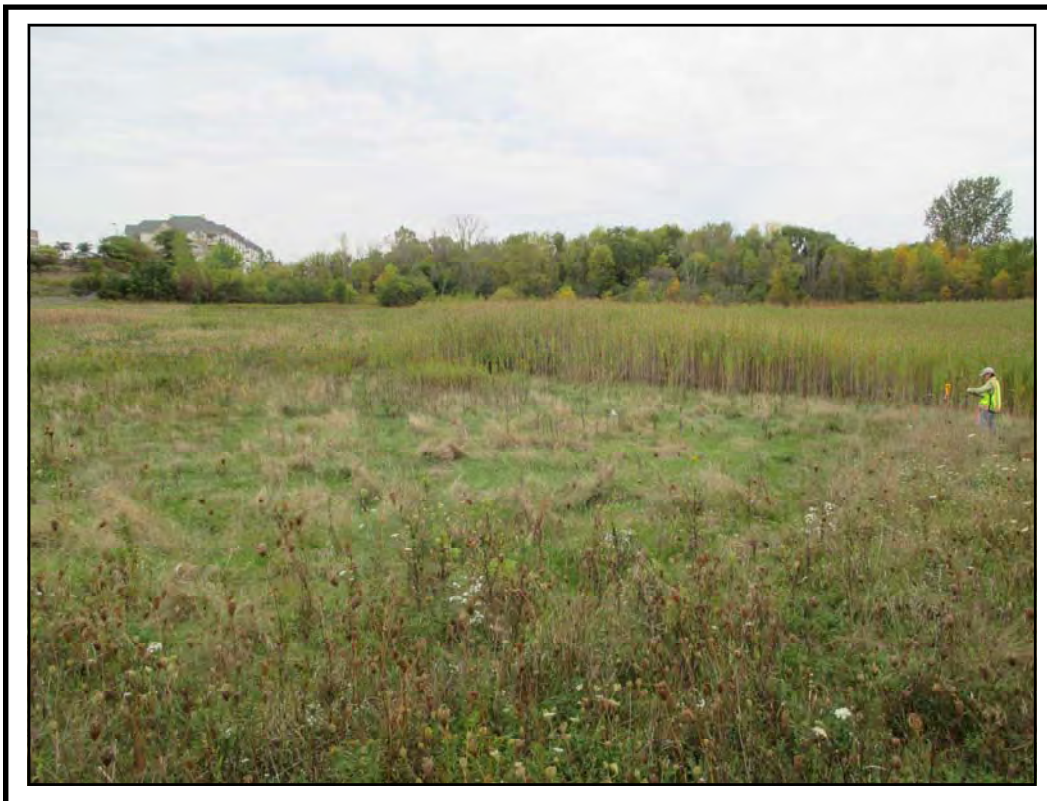
**Photograph 2 (9/28/15):** Southwest facing view of W-2 and it's adjacent upland meadow. W-1 is also visible on the far left side of the photo.

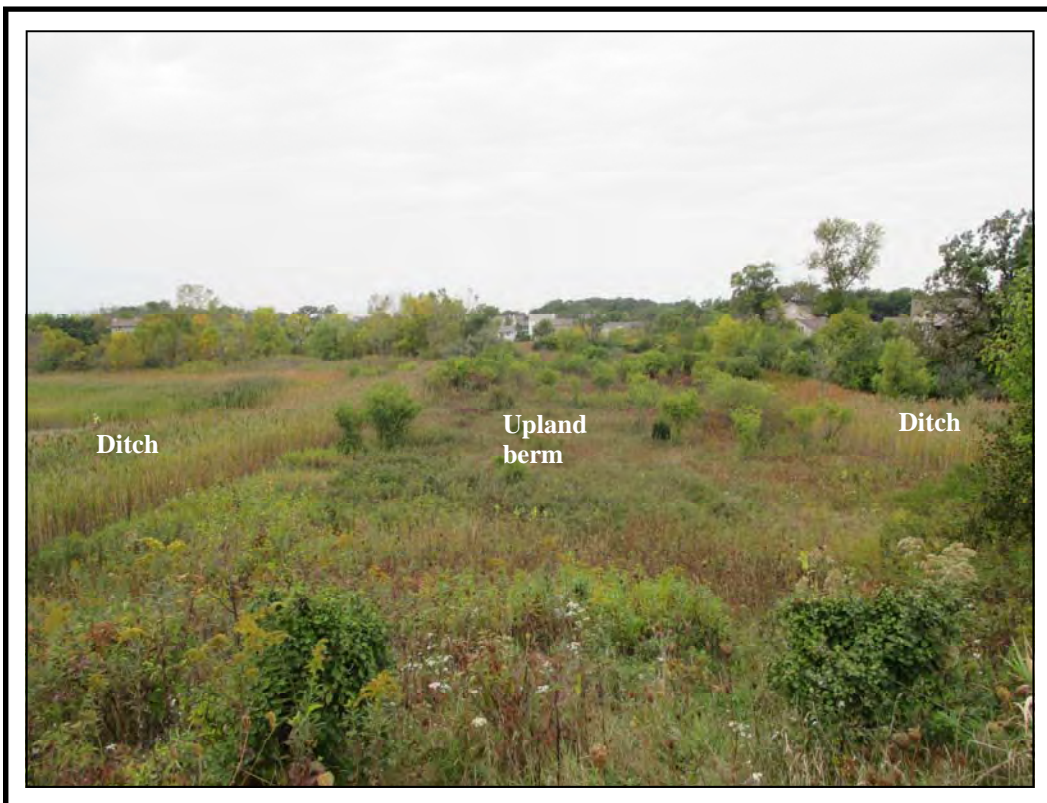
**Photograph 4 (9/28/15):** West facing view of the two wetland ditches that are associated with W-2, as well as the upland berm between them.

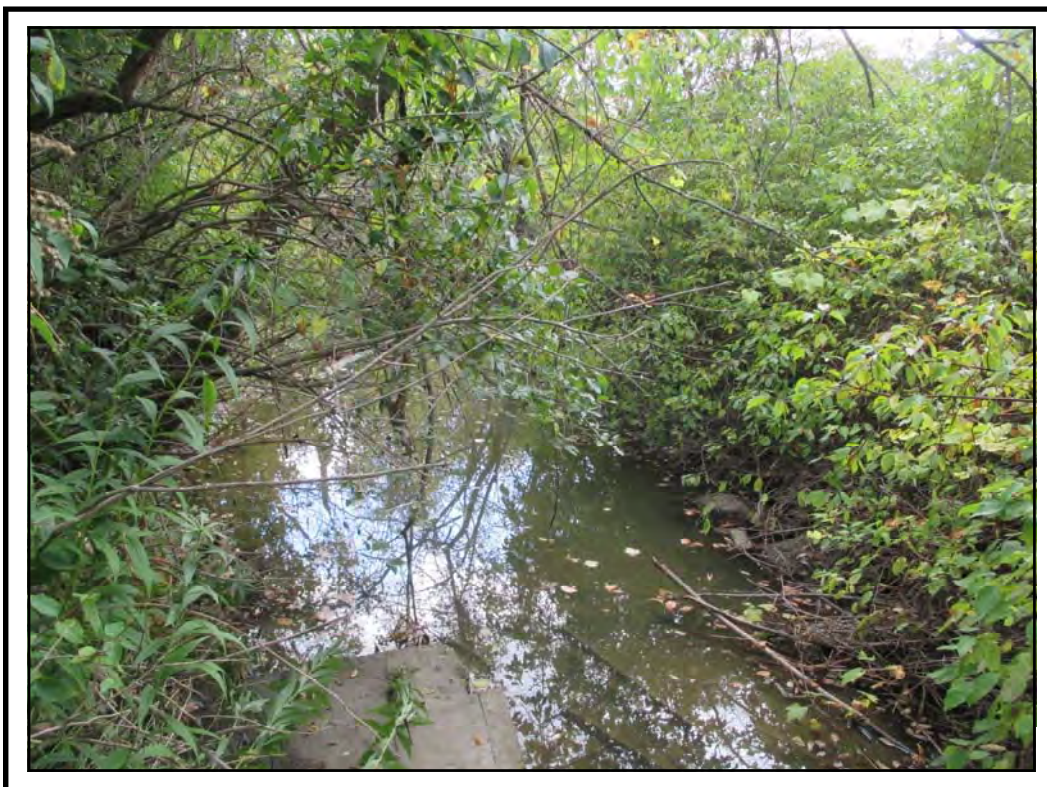
**Photograph 6 (9/28/15):** South facing view of the waterway that traverses south along the western boundary of the site.

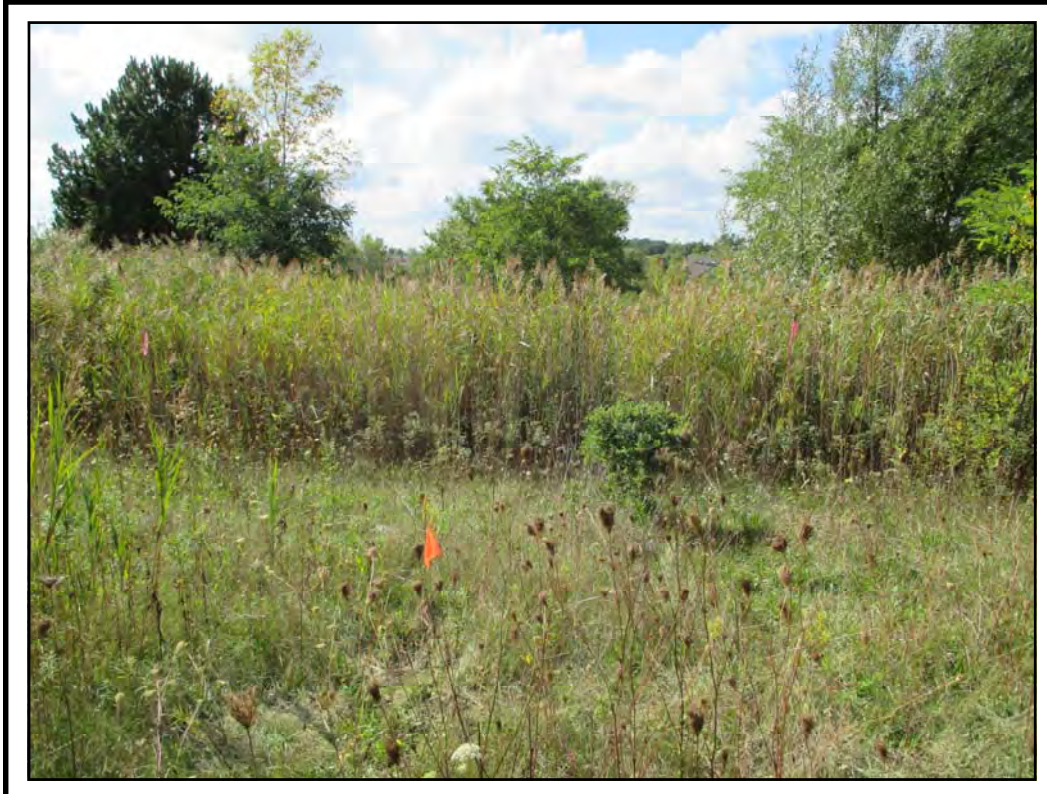
**Photograph 7 (9/28/15):** West facing view of W-3, a degraded fresh wet meadow dominated by giant reed grass (*Phragmites australis*). Upland data point DP-12 is visible in the foreground.

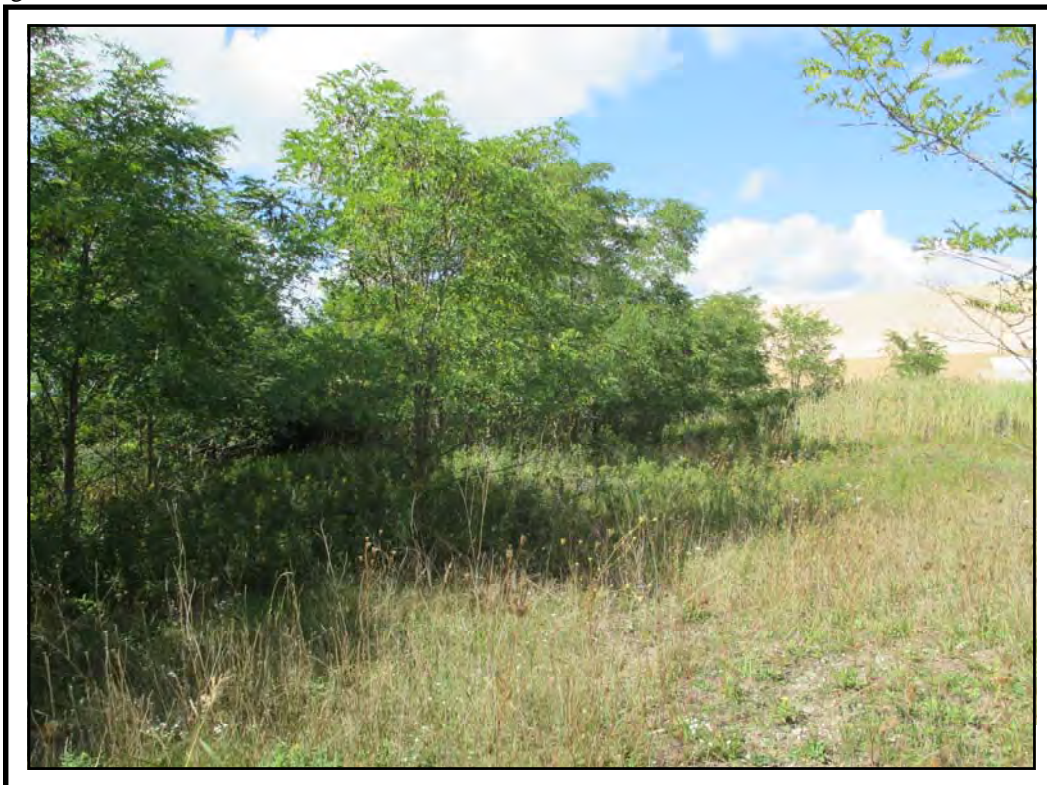
**Photograph 8 (9/28/15):** General north facing view of the uplands on the north side of the site which were dominated by mostly invasive and weedy species.
