Project Name Site Location Project No.

Carlisle Interconnect 5300 W. Franklin Dr., Franklin, WI 255682

# APPENDIX E: WETLAND DETERMINATION DATA FORMS

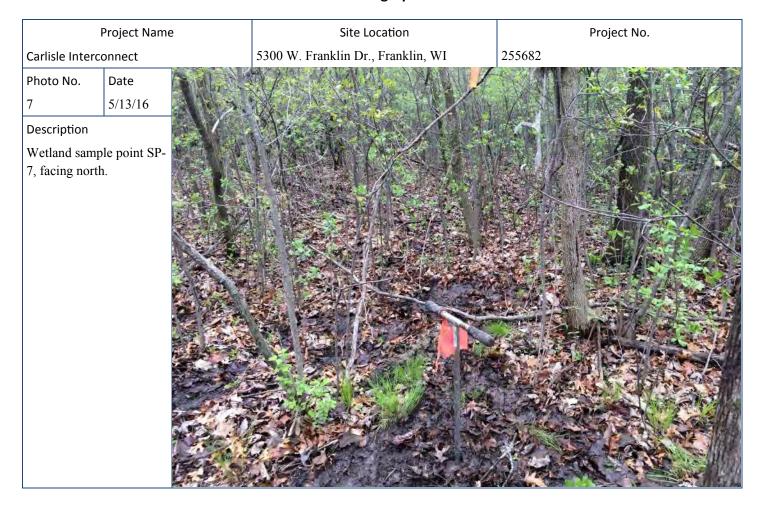
Photo No. Date 8 5/13/16

Upland sample point SP-8, facing south-southeast.

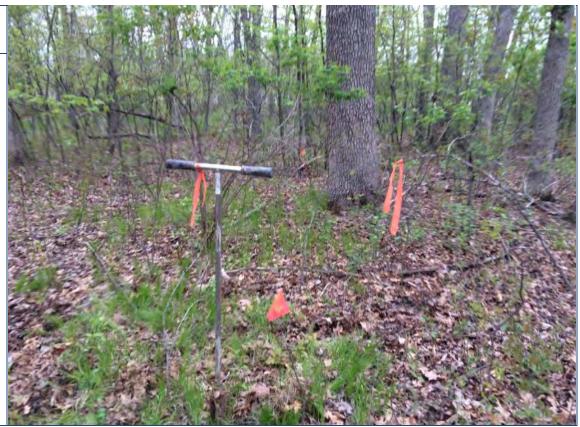
11 5/13/16

Wetland sample point SP-11, facing northwest.

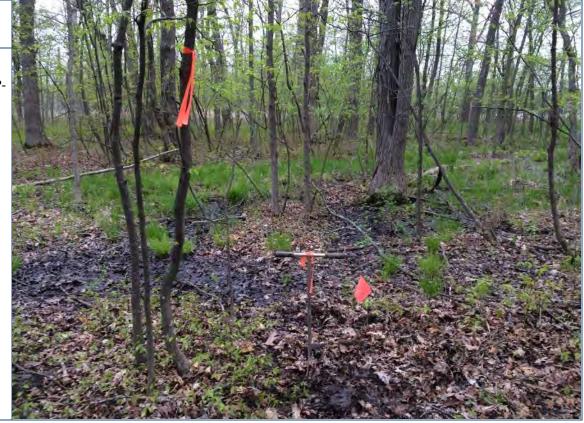
12 5/13/16

Wetland sample point SP-12, facing west.

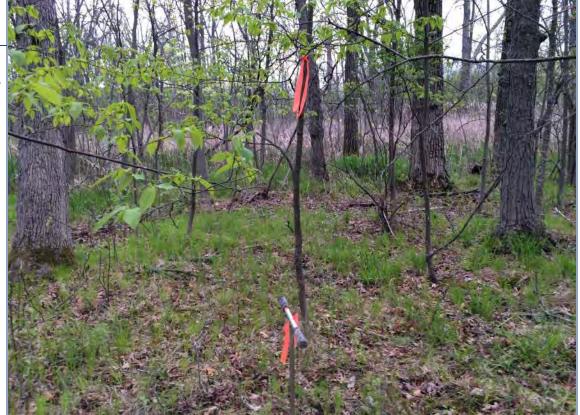
12

Representative photo of shallow roots on *Ostrya virginiana* in hardwood swamp.

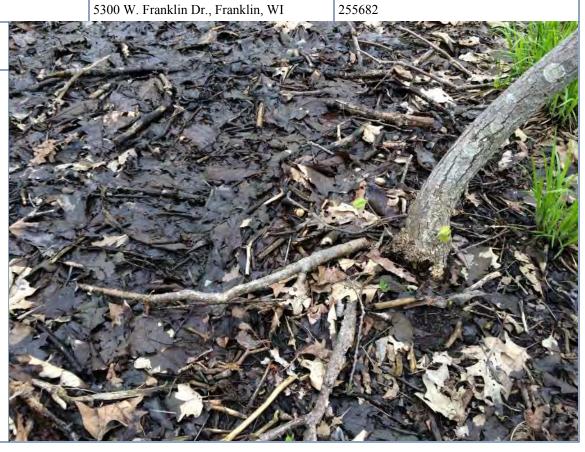
13

Representative photo of adventitious/shallow roots on *Rhamnus cathartica* in hardwood swamp.

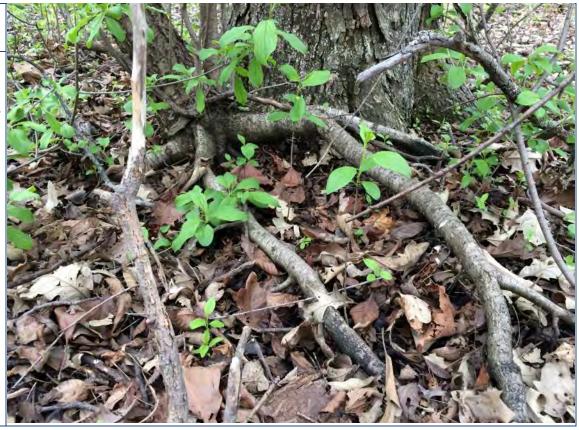
Representative photo of adventitious/shallow roots on *Ostrya virginiana*.

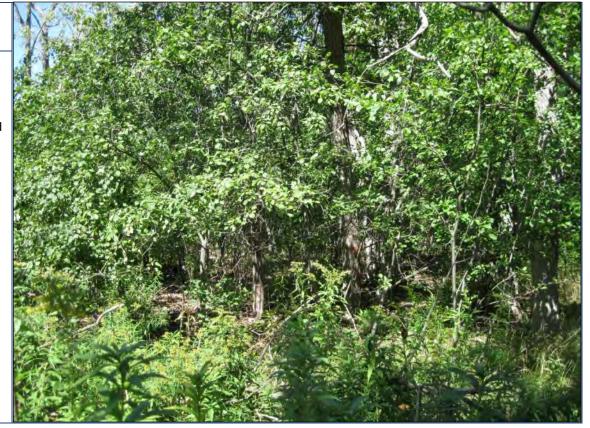
Hardwood swamp wetland and mature woodland area proposed to be impacted.

Looking south

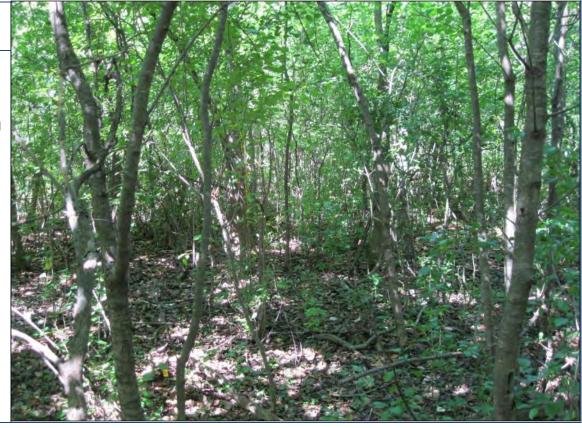
Photo No. Date 9/12/16

Hardwood swamp wetland and wetland, mature woodland, and wetland buffer/setback proposed to be impacted.

Looking north

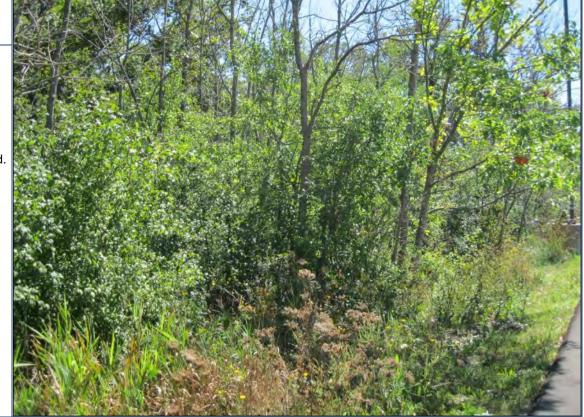
Hardwood swamp wetland, mature woodland, and wetland buffer/setback proposed to be impacted.

Looking east

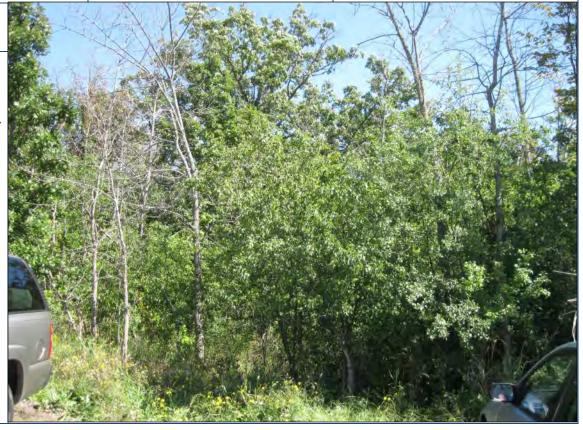
6 5/11/16

Hardwood swamp wetland, mature woodland, and wetland buffer/setback proposed to be impacted.

Looking west from within mature woodland.

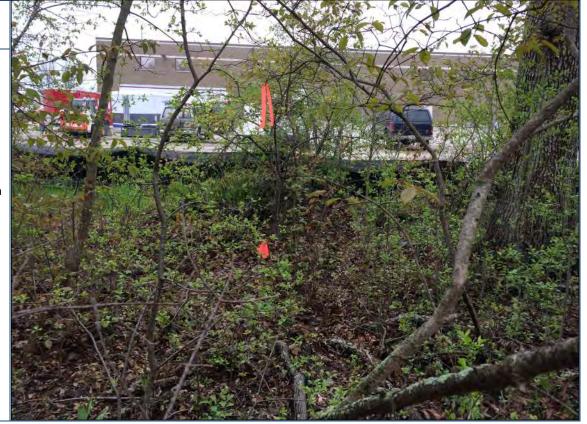
North end of northwest parking lot with where the invasive grass Phragmities occurs. Herbicide treatment and native seeding will be conducted here for mitigation.

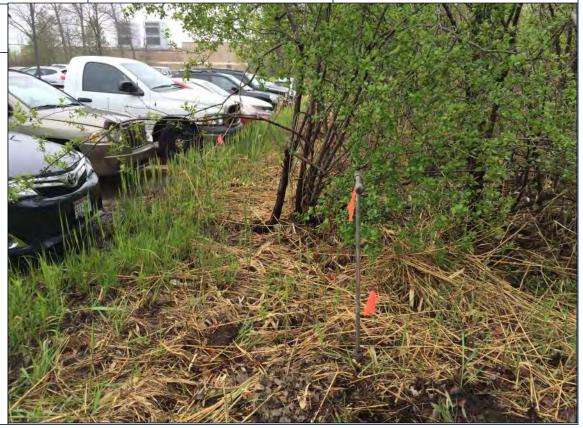
North side of parking where wetland buffer can be enhanced and general area where native tree saplings can be plated for mitigation.

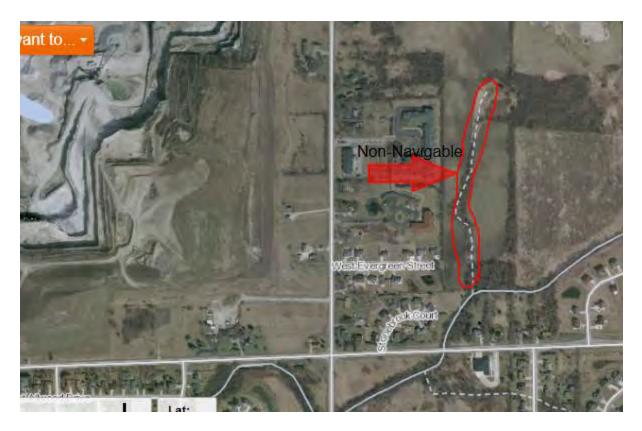
Non-Navigable tributary to Root River. Site visit 09/07/2016
